**Photographs from August 21, 2015**  
**Peskin Building – 21 East Athens Street**  
**Winder, Georgia**

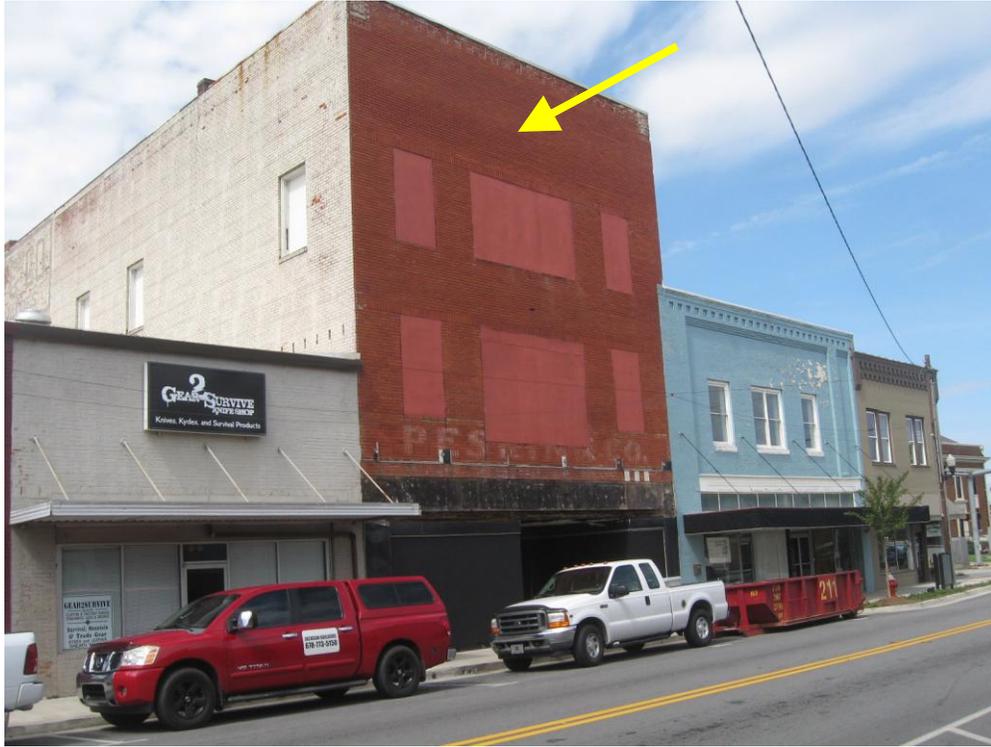
Photograph #1: Front (north) view of the building.

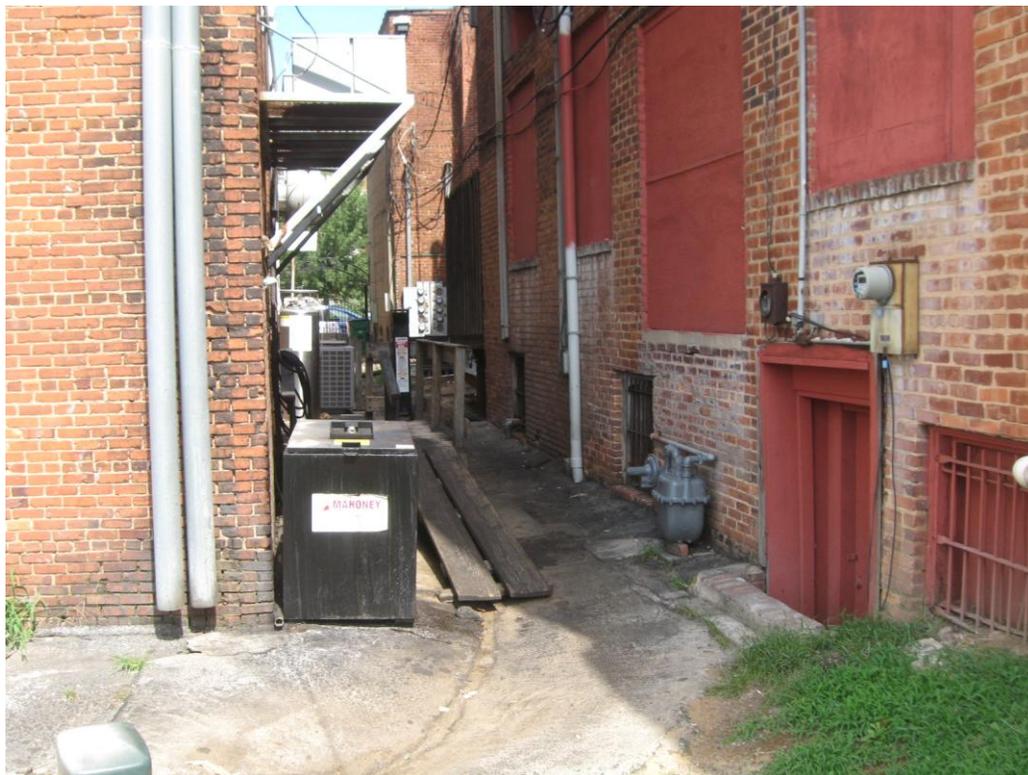
Photograph #2: Rear alley to the south of the building.

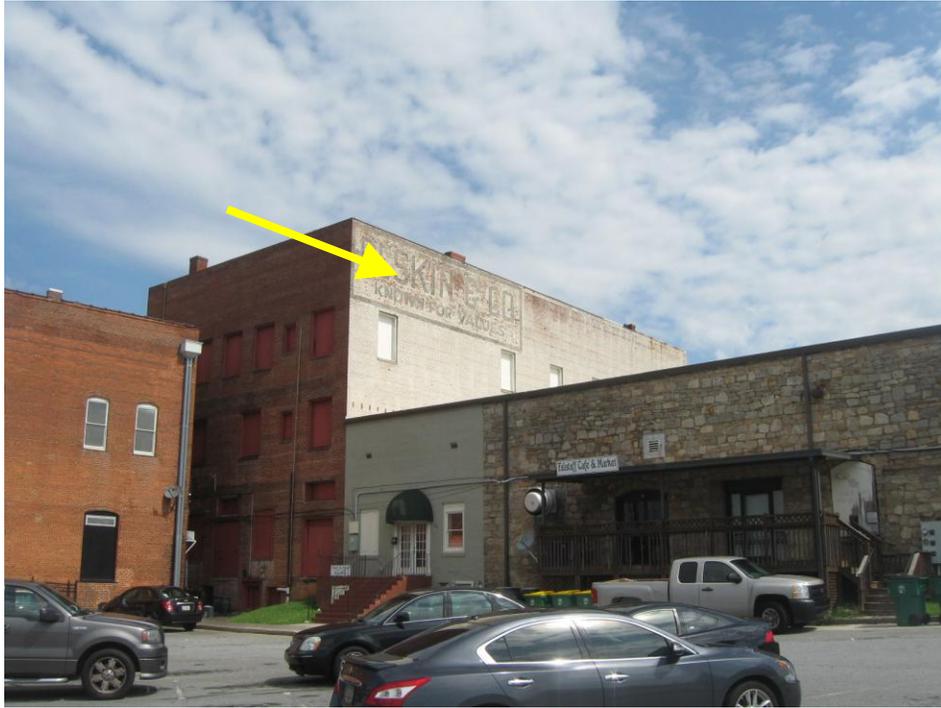
Photograph #3: View facing the southeast corner of the building.

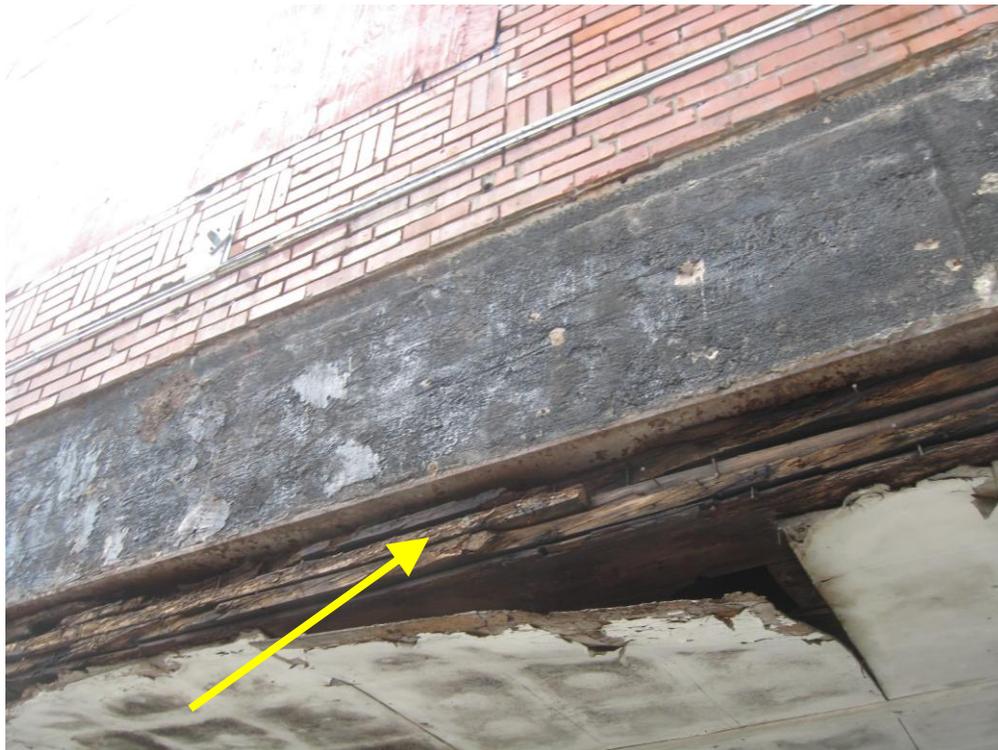
Photograph #4: Apparent lintel at the front wall above the sidewalk with deteriorated wood framing below.

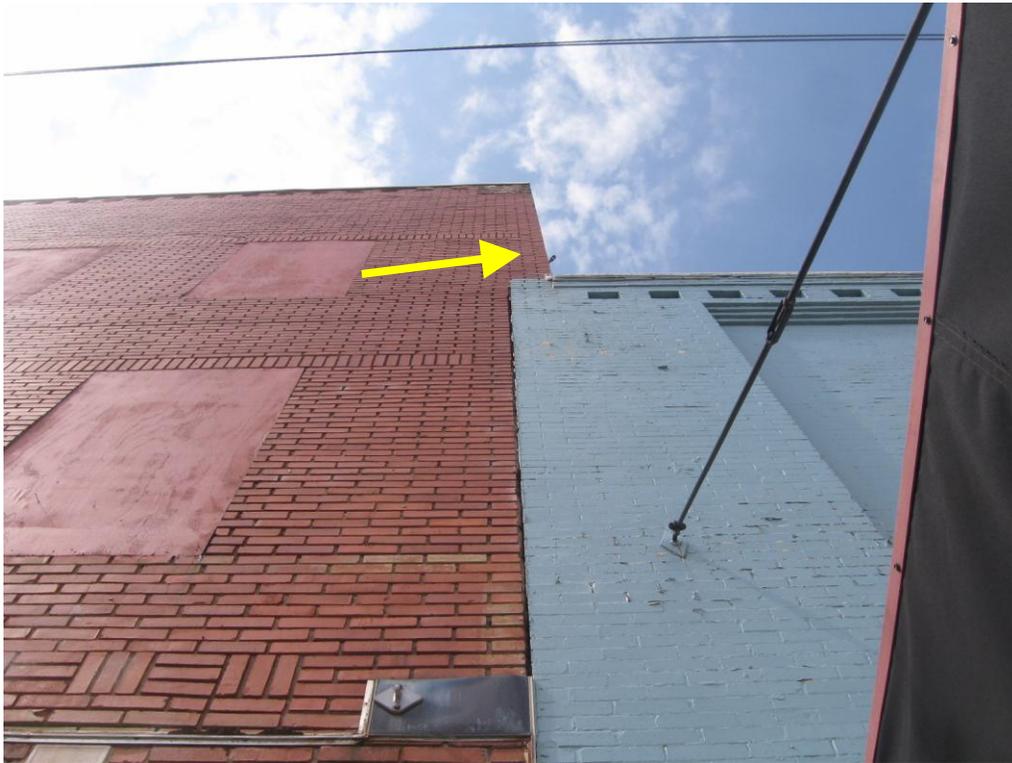
Photograph 5: Joint in the front wall between the Peskin Building and the adjacent building to the west. Note the overlap at/above the third floor.

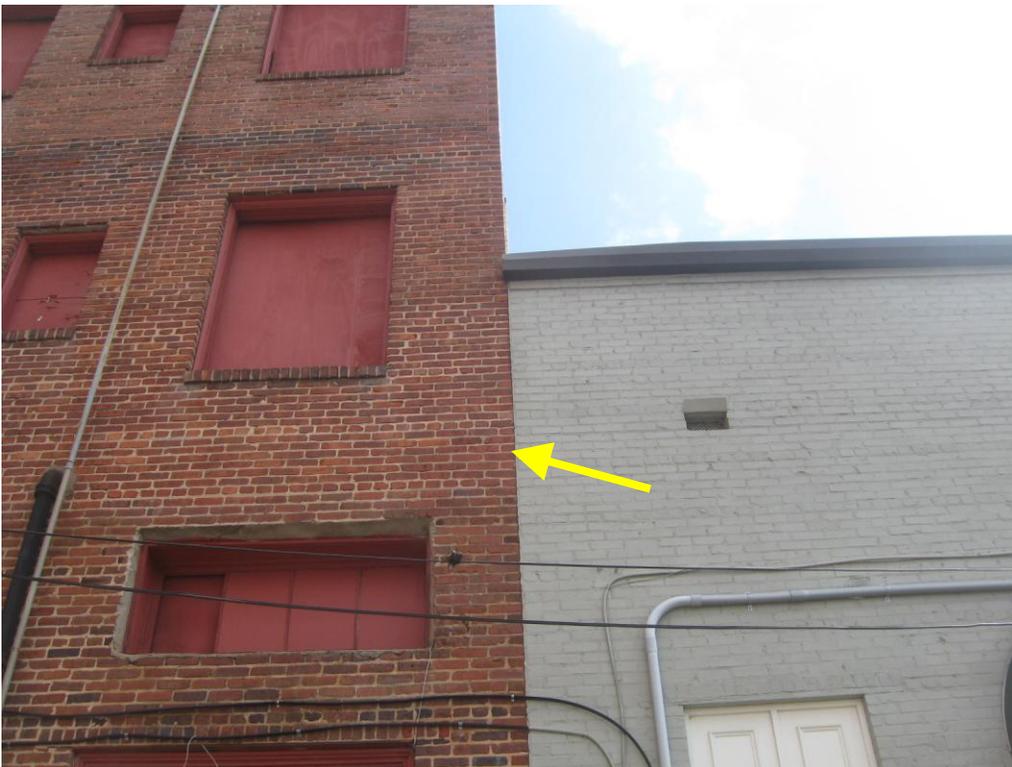
Photograph #6: Joint in the rear wall between the Peskin Building and the adjacent building to the east.

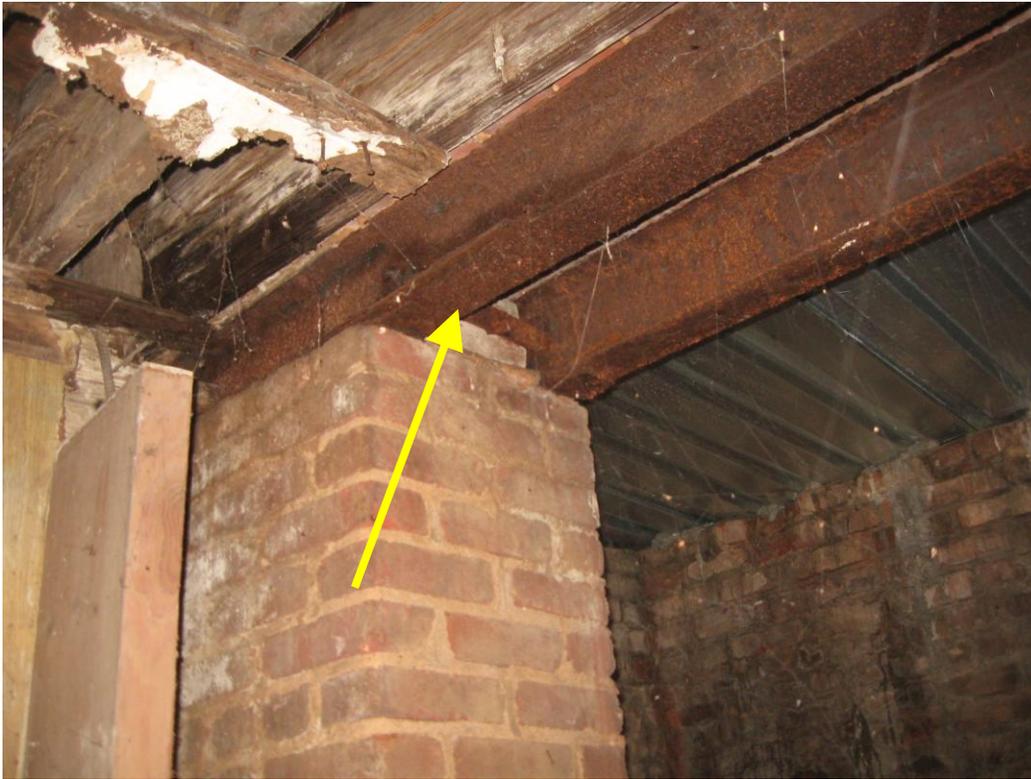
Photograph #7: Steel beams in the basement below the front wall at the sidewalk - with some corrosion – particularly above the brick piers.

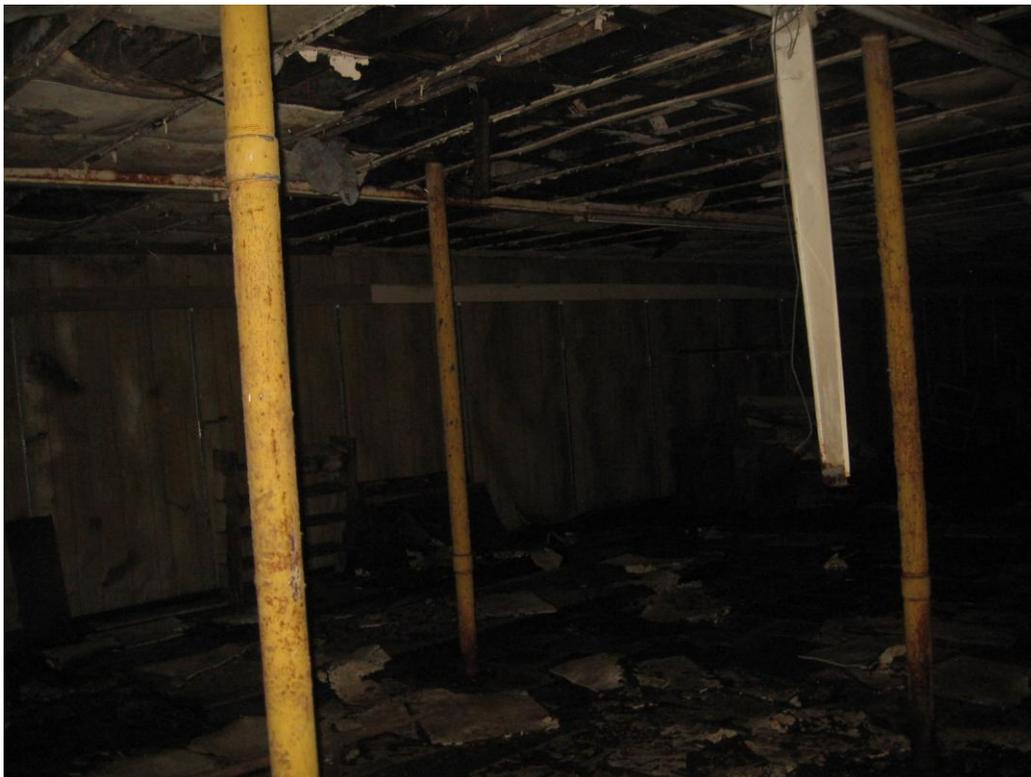
Photograph #8: Basement conditions with standing water and damaged first floor framing overhead.

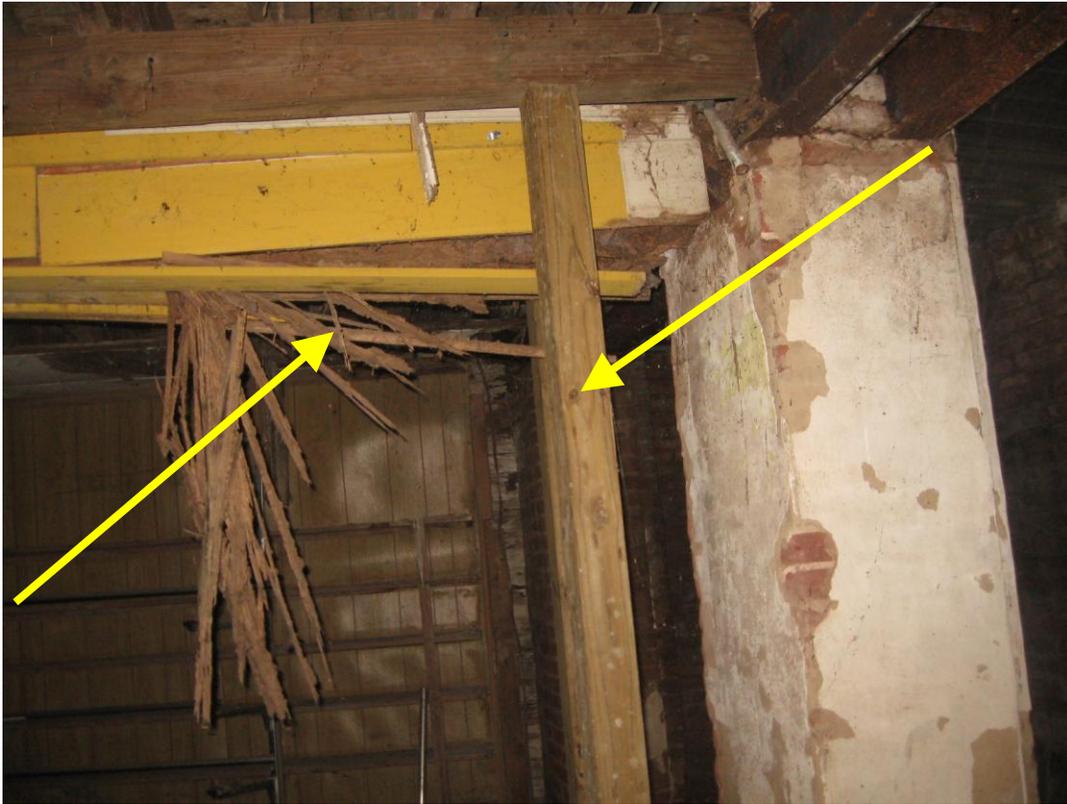
Photograph #9: Failed 1<sup>st</sup> floor center beam, viewed from the basement near the front wall – with shoring posts/beams added.

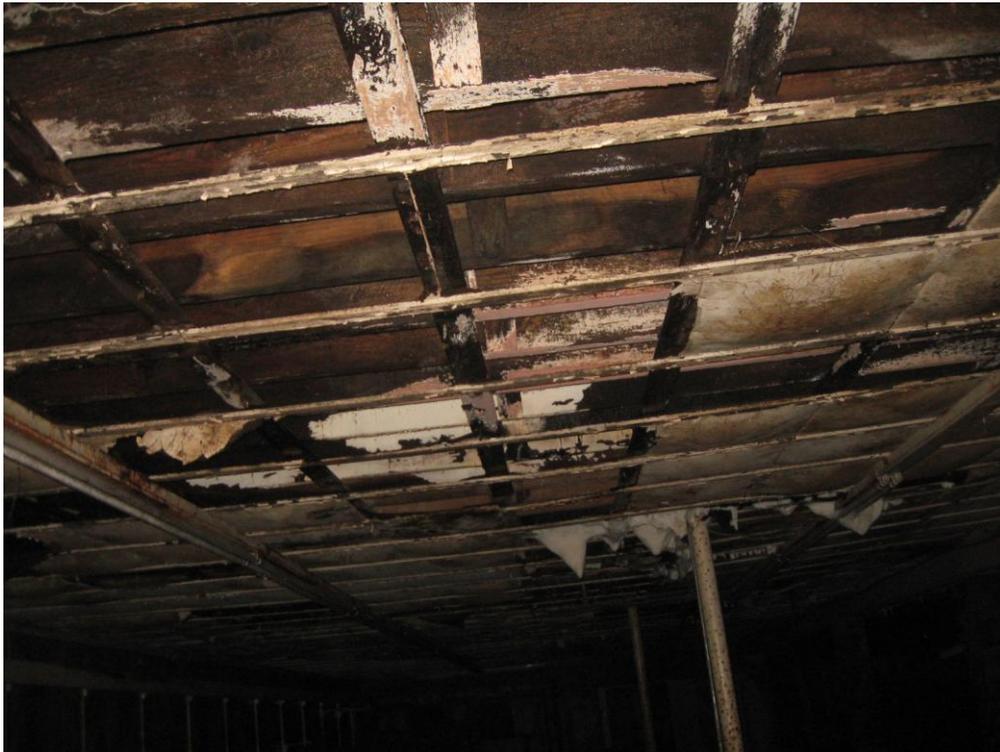
Photograph #10: Wet, damaged first floor framing viewed overhead in the basement.

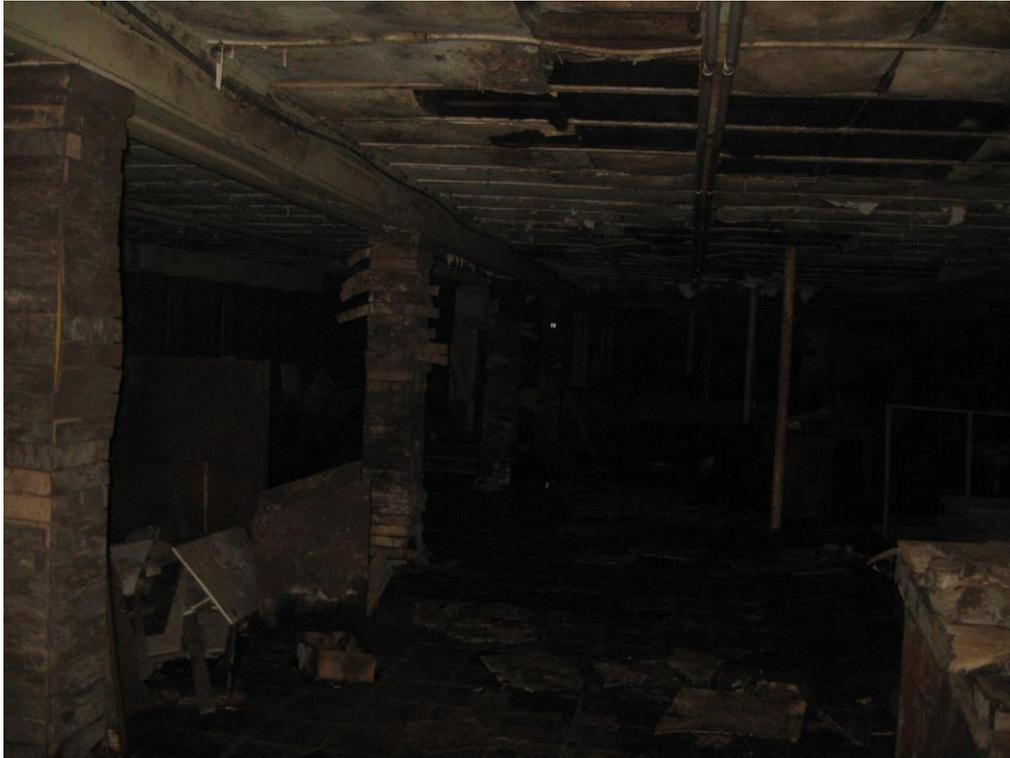
Photograph #11: Basement conditions including center columns and ceiling - partially in place.

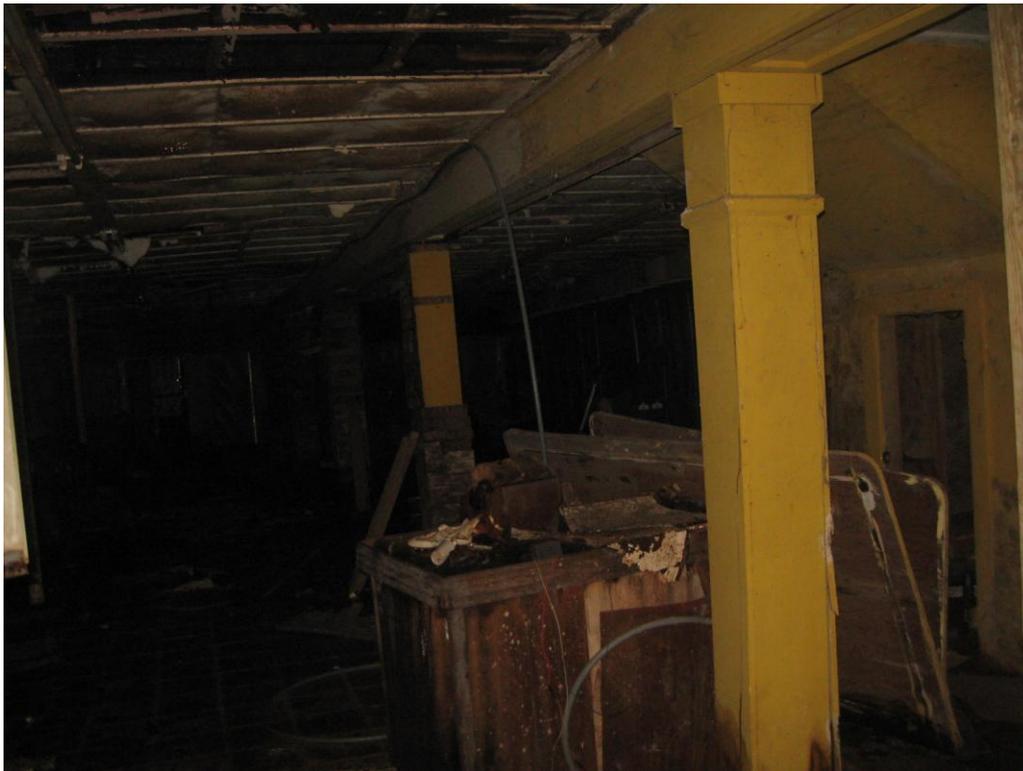
Photograph #12: Basement conditions including the center beam and columns supporting the first floor joists.

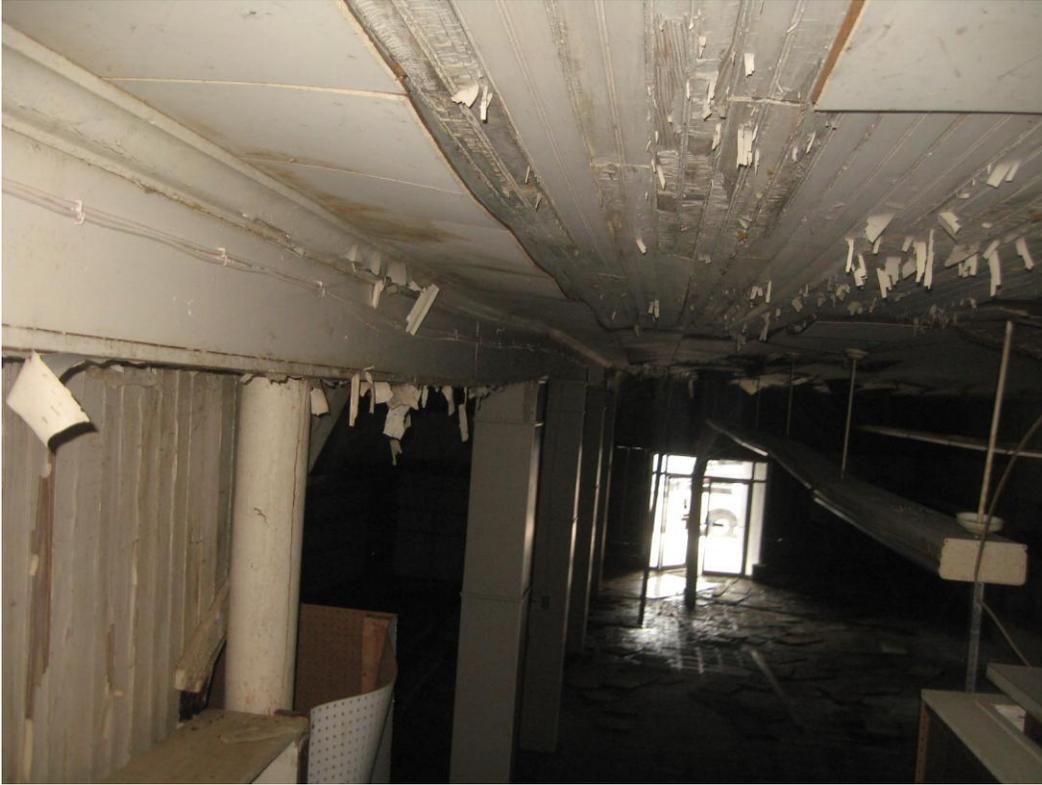
Photograph #13: First floor conditions including the center beam, and columns, supporting the 2<sup>nd</sup> floor framing.

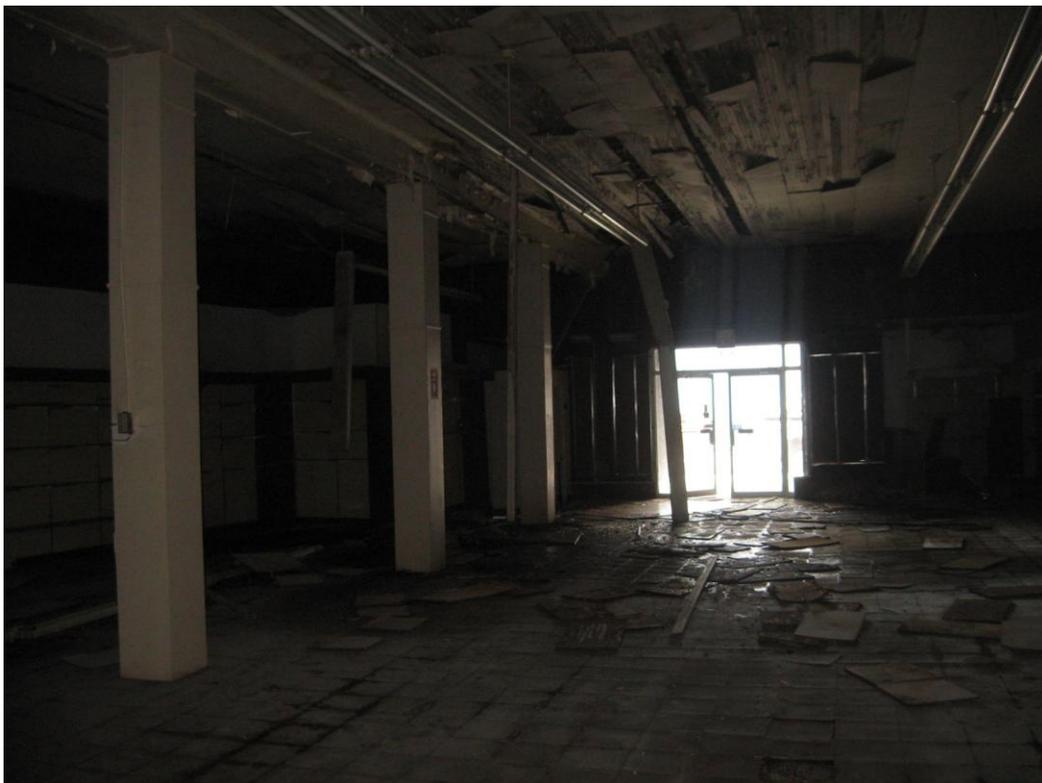
Photograph #14: First floor conditions.

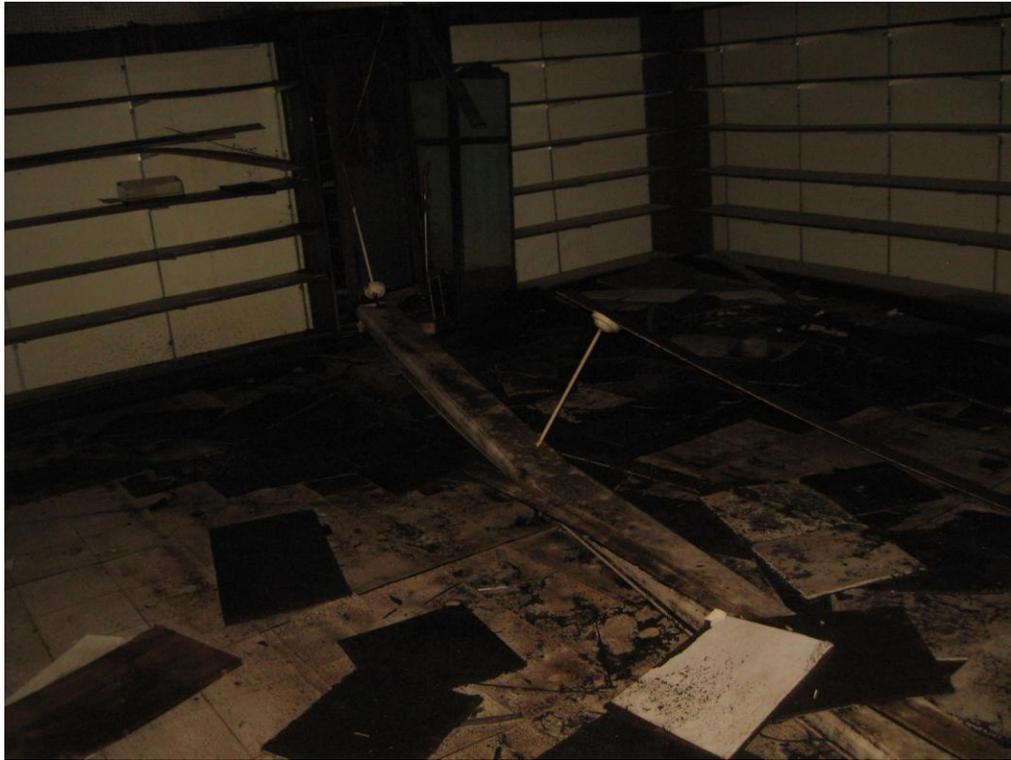
Photograph #15: Wet, damaged area of the first floor.

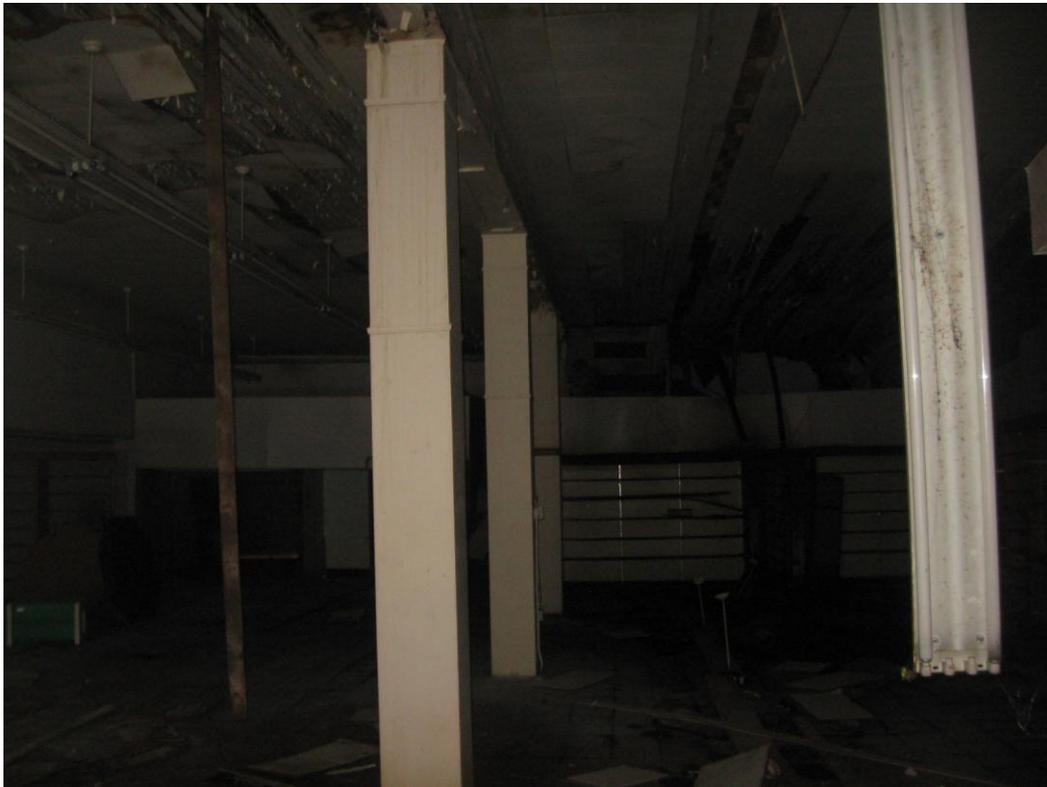
Photograph #16: First floor conditions including the interior mezzanine at the rear of the building.

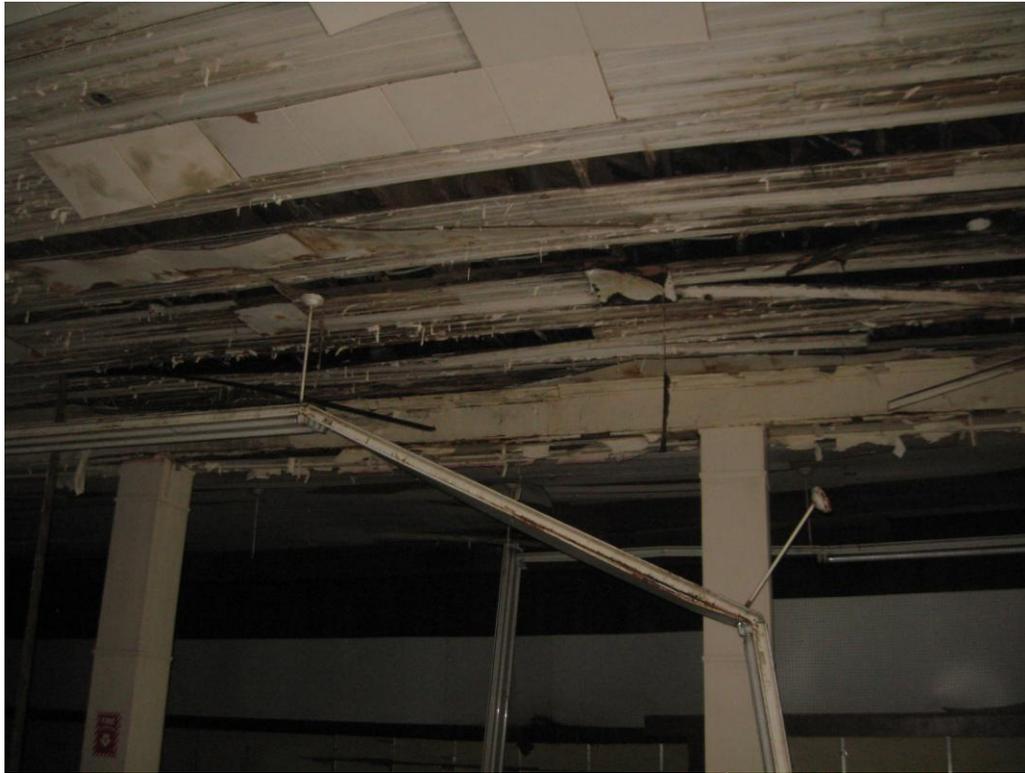
Photograph #17: Damaged first floor ceiling (and 2<sup>nd</sup> floor joists above).

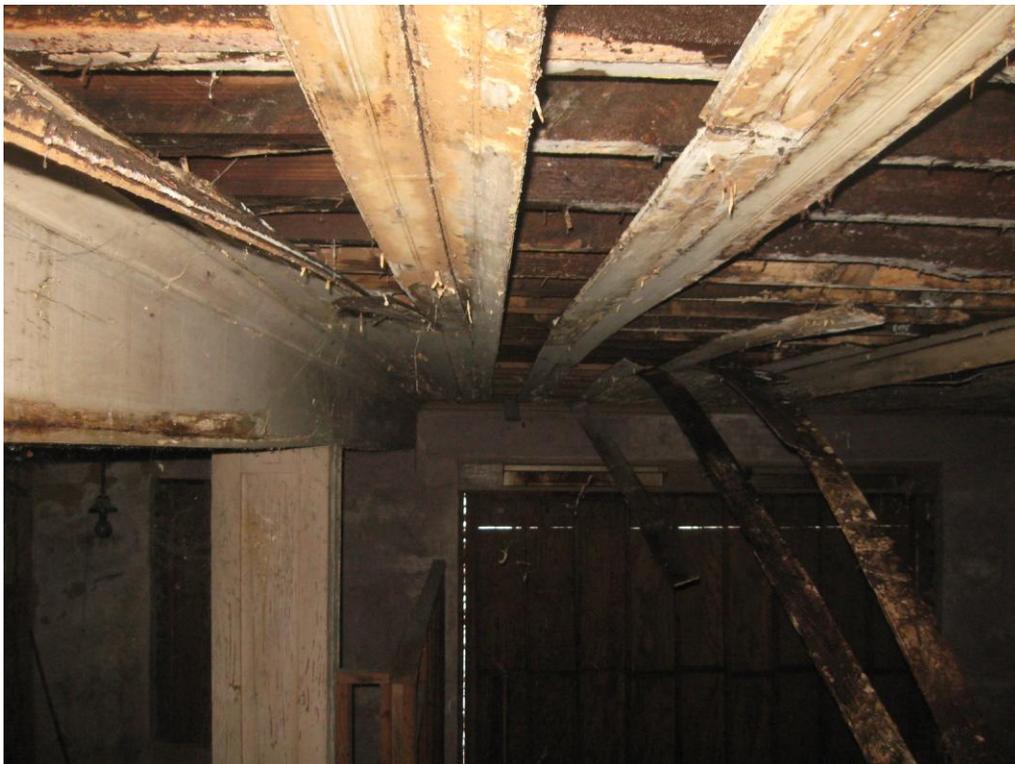
Photograph #18: 3<sup>rd</sup> floor beam and joists viewed overhead from the 2<sup>nd</sup> floor.

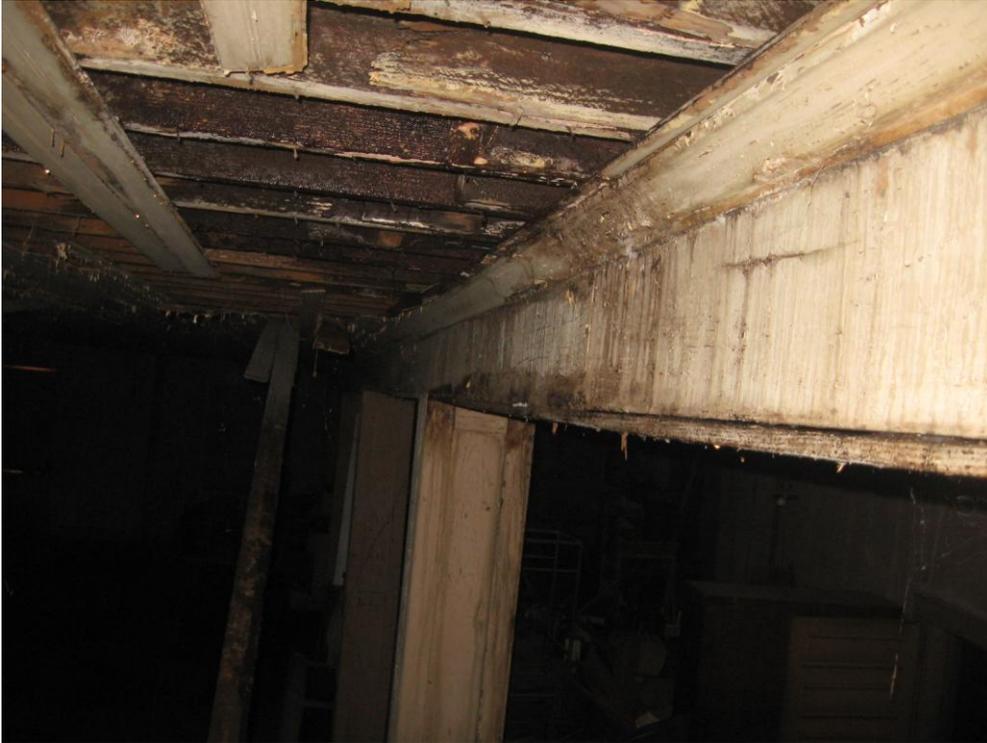
Photograph #19: 3<sup>rd</sup> floor beam and joists viewed overhead from the 2<sup>nd</sup> floor.

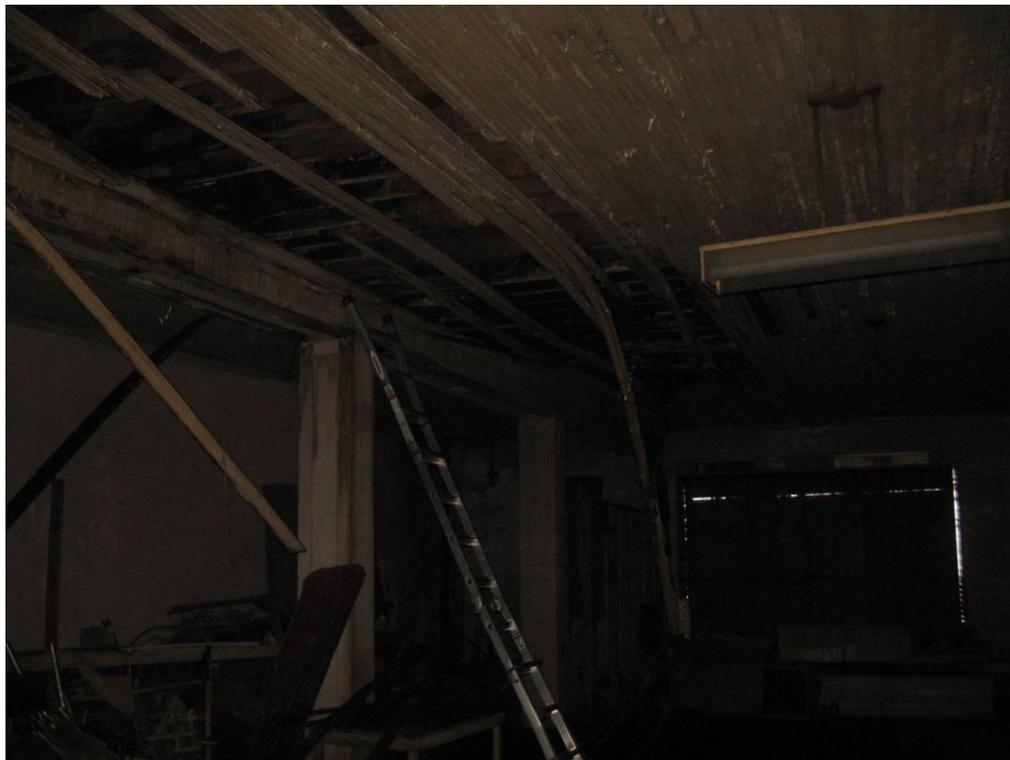
Photograph #20: 2<sup>nd</sup> floor conditions including the center beam/columns and the damaged ceiling (and 3<sup>rd</sup> floor joists above).

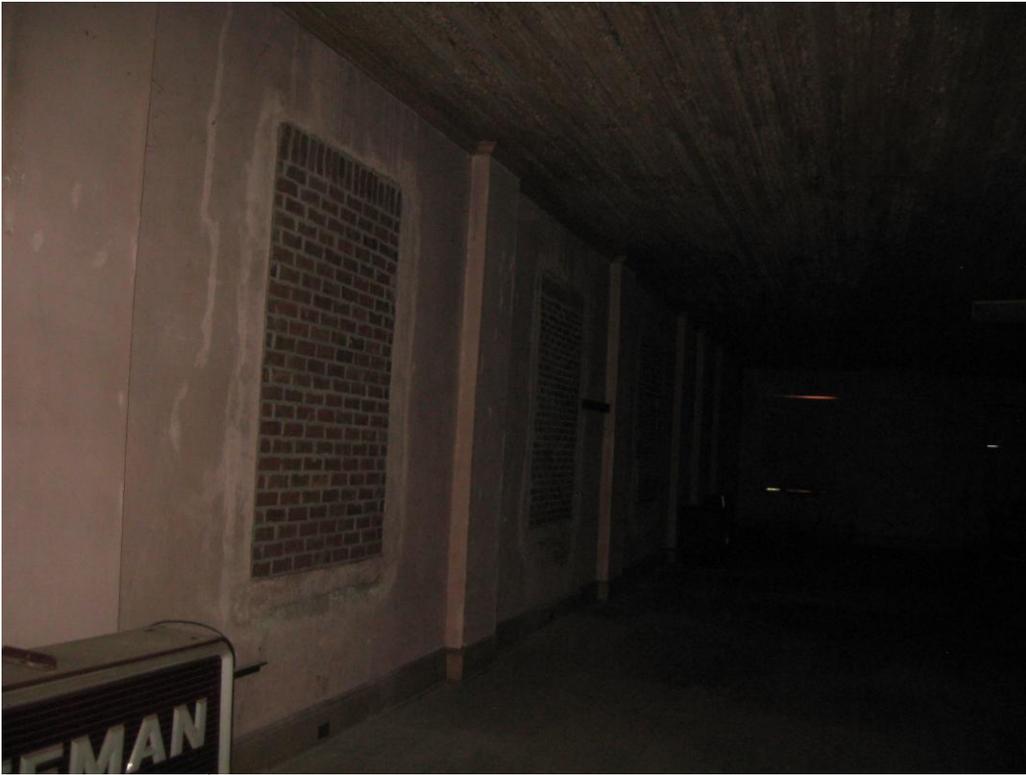
Photograph #21: 2<sup>nd</sup> floor, east, exterior wall with brick infill at prior window openings.

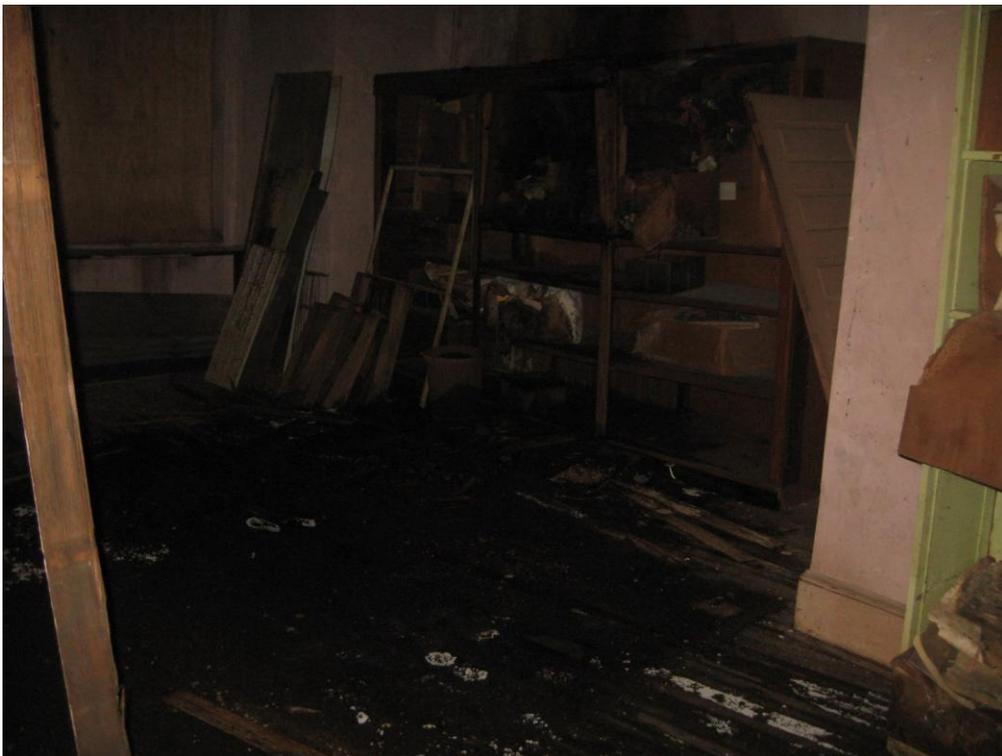
Photograph #22: Wet, damaged area of the 2<sup>nd</sup> floor.

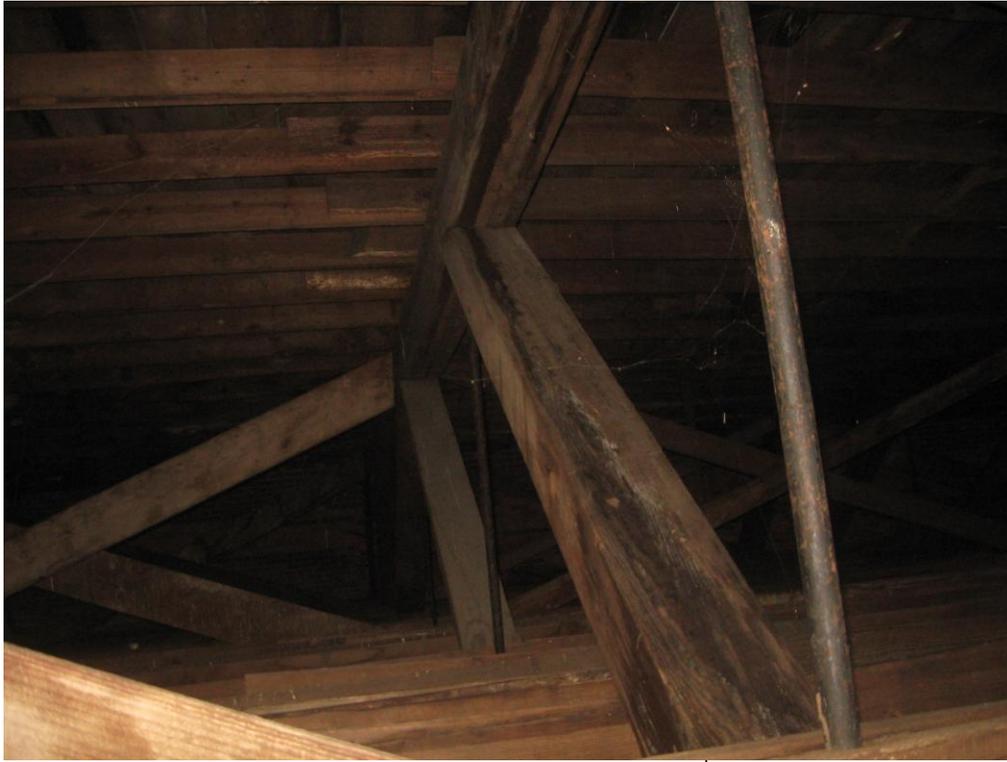
Photograph #23: Roof trusses, viewed overhead from the 3<sup>rd</sup> floor, supporting rafters and ceiling joists.

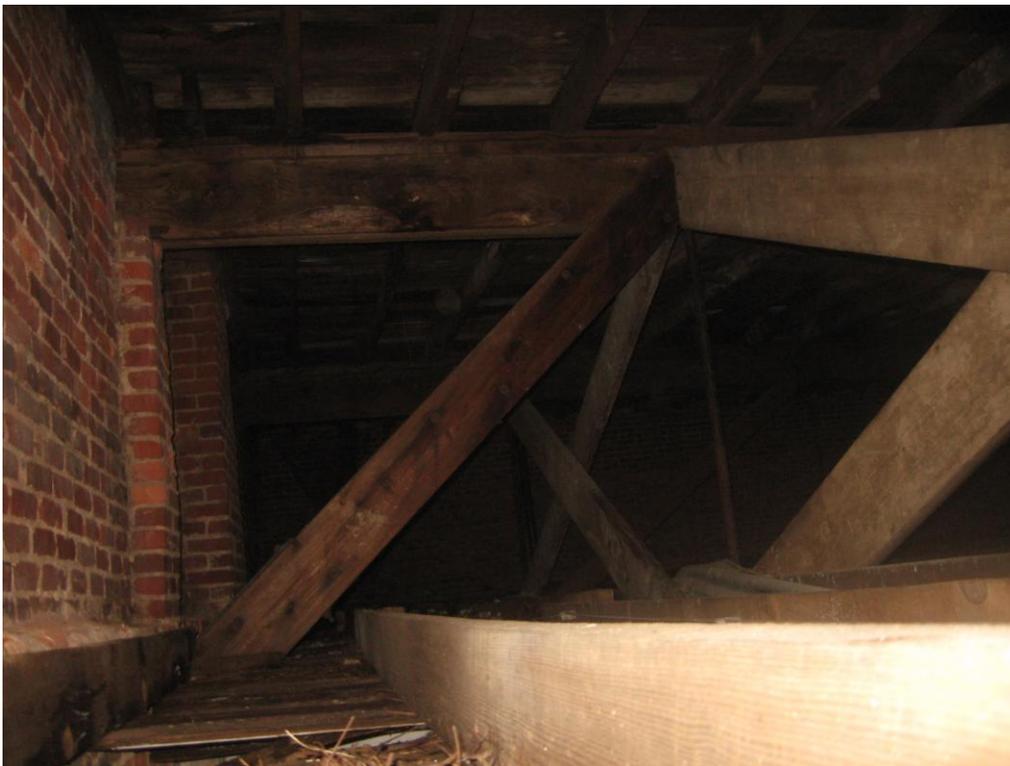
Photograph #24: Roof trusses, viewed overhead from the 3<sup>rd</sup> floor, supporting rafters and ceiling joists – adjacent to the east wall.

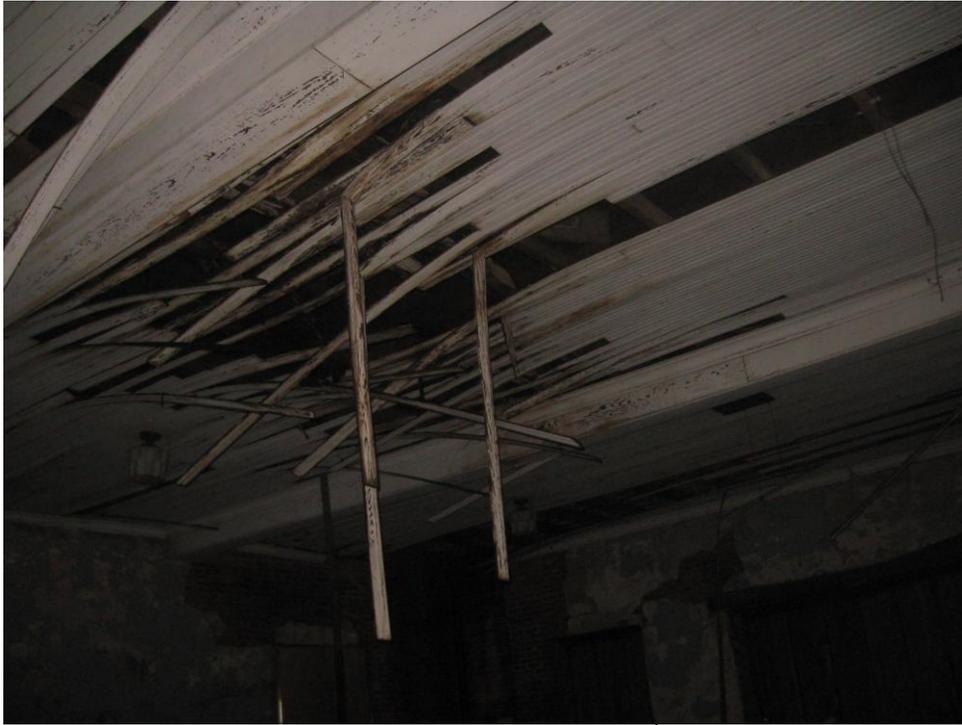
Photograph #25: Damaged area of the 3<sup>rd</sup> floor ceiling.

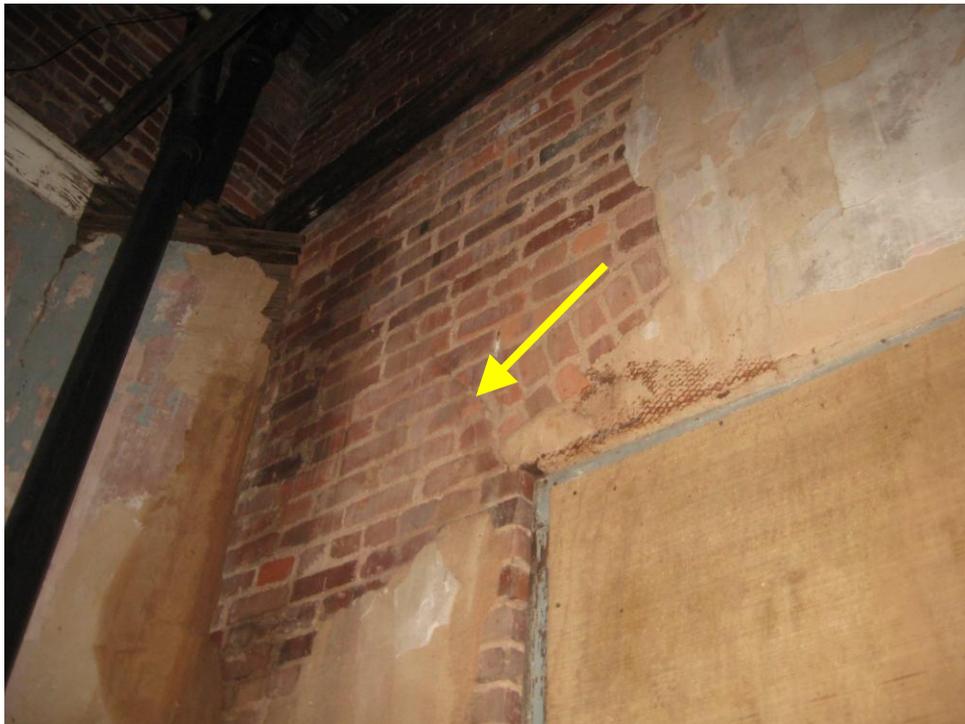
Photograph #26: Crack in the brick exterior wall above the window corner at the 3<sup>rd</sup> floor.

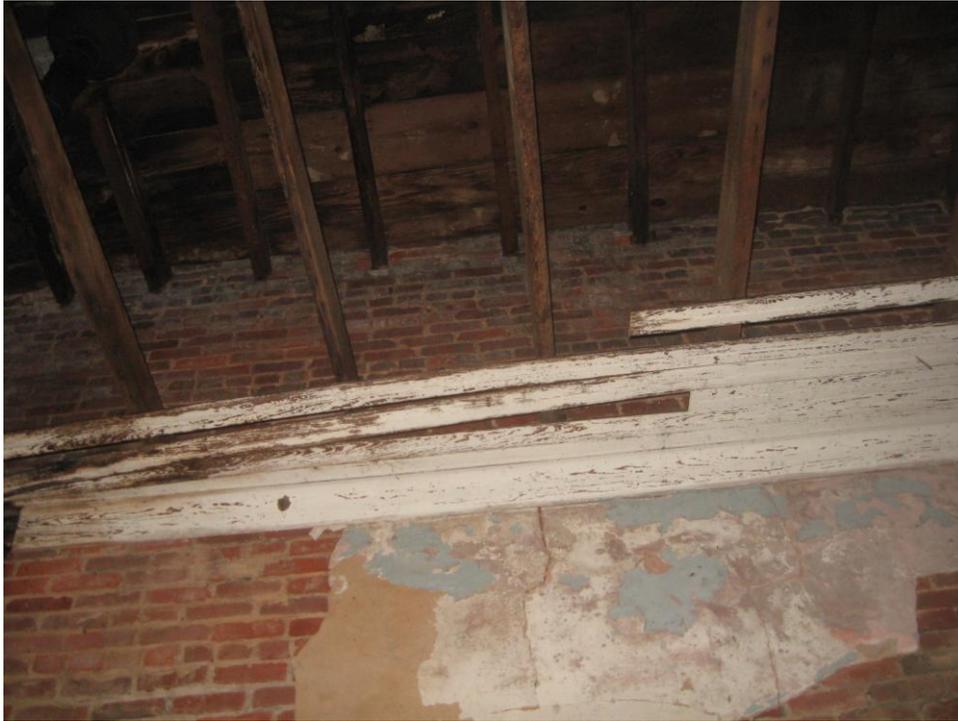
Photograph #27: 3<sup>rd</sup> floor ceiling joists and rafters pocketed into the brick wall.

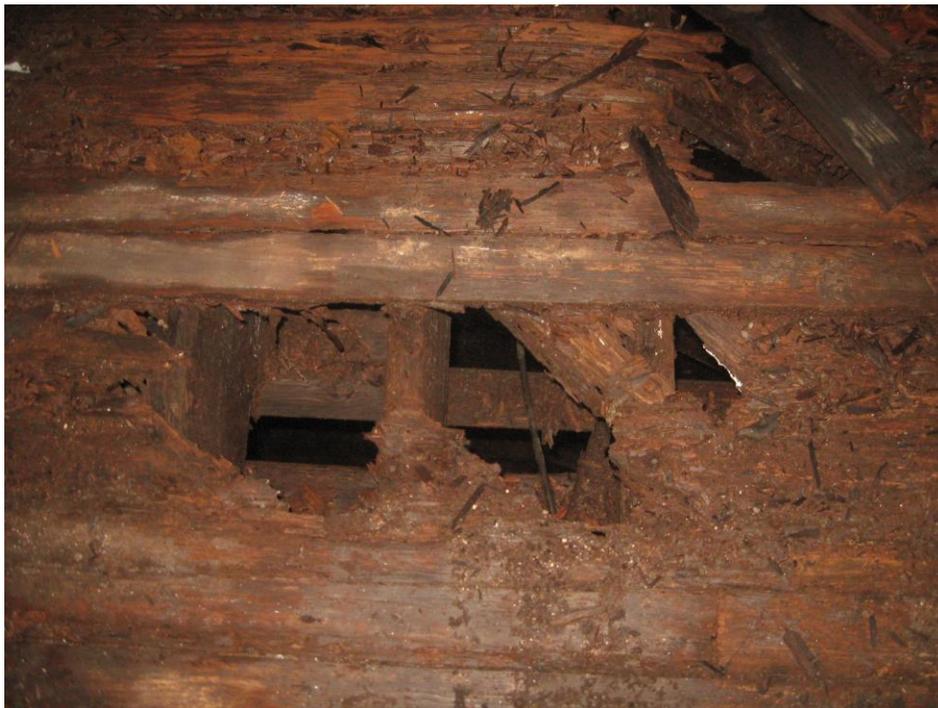
Photograph #28: Damaged area of the 3<sup>rd</sup> floor.

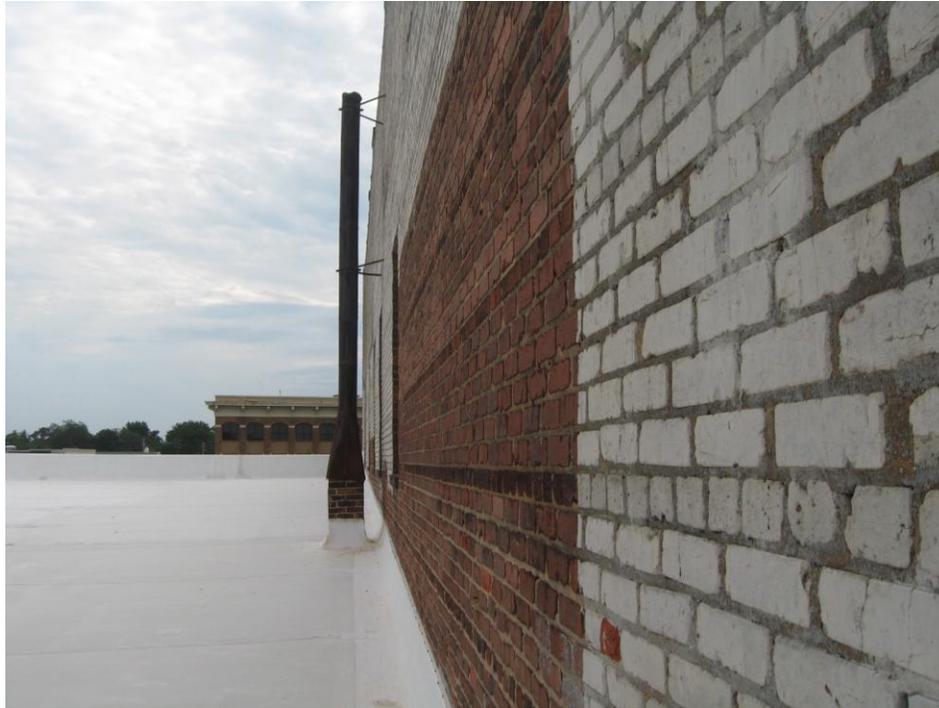
Photograph #29: West wall of the Peskin building above the roof of the two-story building to the west.
