**Photographs from August 21, 2015**  
**Peskin Building – 21 East Athens Street**  
**Winder, Georgia**

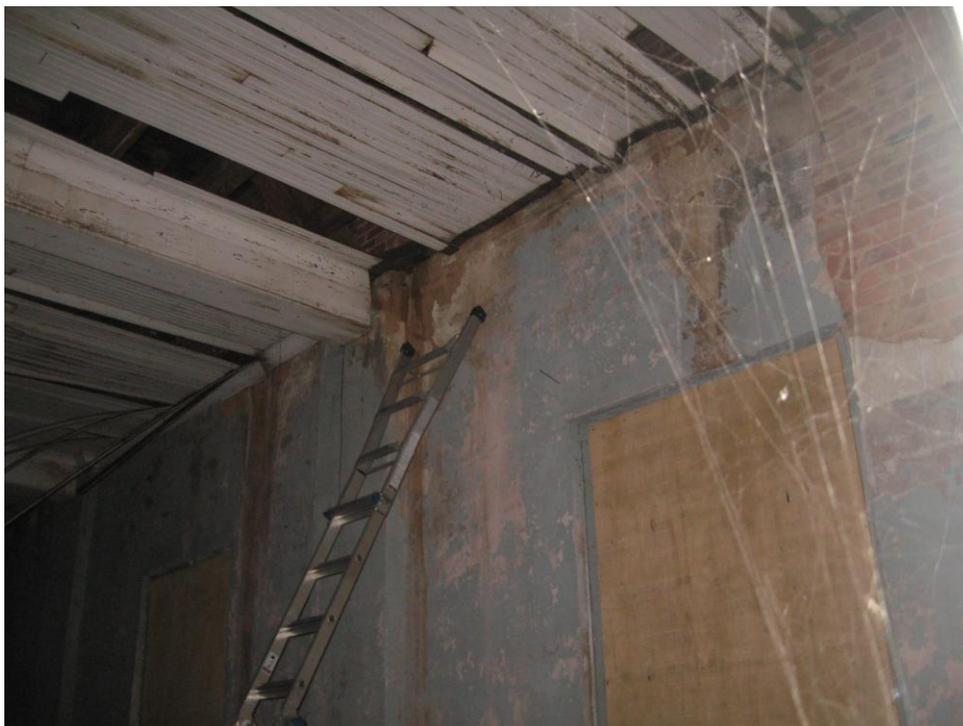
Photograph #30: East wall of the Peskin building and 'beam' viewed overhead at the 3<sup>rd</sup> floor.
